SERVICE BULLETIN

IMPORTANCE	High
AREA AFFECTED	Nose gear
SB SERIAL NUMBER	Cheetah/004/222011

SUBJECT: Nose gear hairline cracks

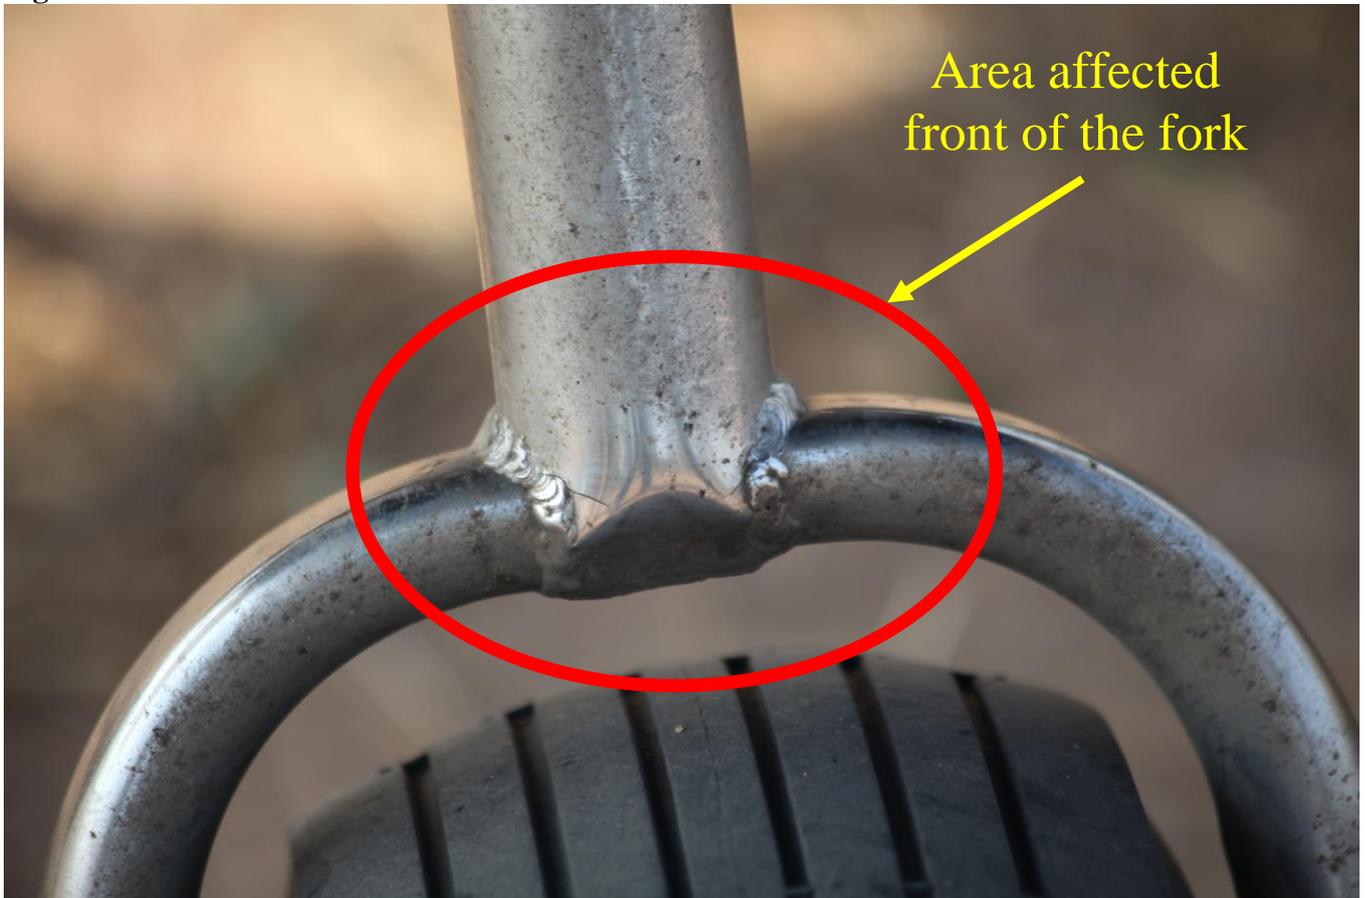
Figure 1

Two Aircraft reported finding hairline cracks on the nose gear fork. These aircraft is involved in nature reserve operations and regularly encounter rough terrain landings.

The operator reported two small hairline cracks forming in the area where the strut is welded to the fork. see figure 1

If cracks are found, do not continue operation, contact the factory with immediate effect. Parts or repairs will be discussed.

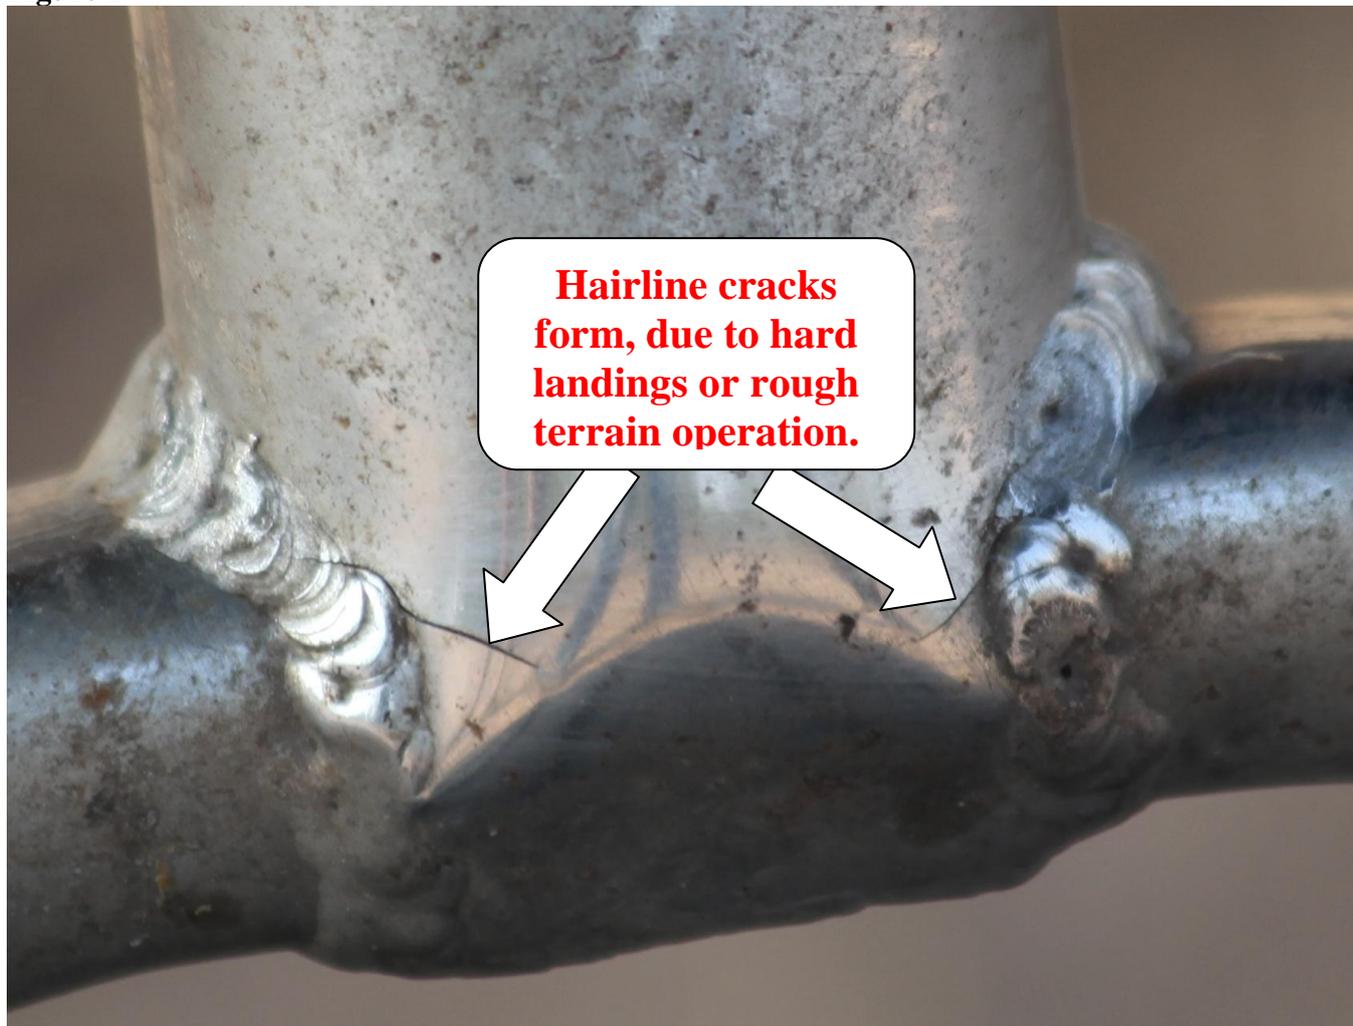
Figure 2

- 1) Remove the front fork Spat (if installed)
- 2) Clean the affected area in order to better the inspection
- 3) Utilising a bright light, inspect the indicated area **see figure 2**
- 4) If no cracks were found assemble the removed parts
- 5) Continue further operation
- 6) Inspect every 50 normal landings (with Spats)
- 7) Inspect every time with hard landings (with Spats)
- 8) **Include this inspection in your pre-flight if no spats are fitted. This is normally the case with aircraft being utilized as per point 1b**

- 1) Lift the nose gear off the floor and stabilize the aircraft in order to remove the nose gear wheel.
- 2) If the nose gear is off the floor and aircraft is sturdy, Cut the locking wire on the axle bolts
- 3) Remove the nose gear bolts on both sides.
- 4) pay particular attention to the spacers between the Spat and the wheel bearing as these will fall out when the bolts are removed.
- 5) With the bolts removed slide the spat up as far as possible
- 6) Continue by turning the wheel to one side as far as possible.
- 7) Clean the affected area in order to see if any hairline cracks did form.
- 8) Inspect the affected area with the strong light.
- 9) After inspection aircraft can be returned to normal.

- 1) Clean the affected area in order to see if any hairline cracks did form.
- 2) Inspect the affected area with the strong light.
- 3) After inspection aircraft can be returned to normal.
